## Environmental Contaminants Reviews (ECR)

## ASSESSING SHIELDING ADEQUACY OF SELECTED RADIOLOGICAL FACILITIES TO ASCERTAIN RADIATION SAFETY IN IBADAN METROPOLIS

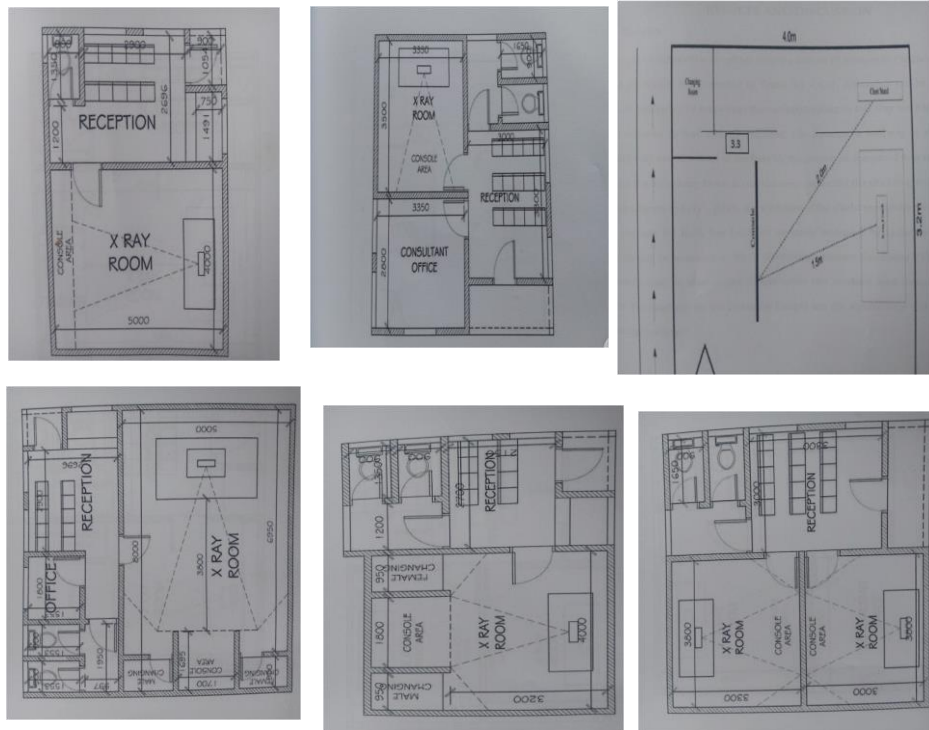
**Figure 2:** (a) Design layout of diagnostics center A (b) Design layout of diagnostics center B (c) Design layout of diagnostics center (d) Design layout of diagnostics center D (e) Design layout of diagnostics center E (f) Design layout of diagnostics center F

Diagnostic Centre D has two X-ray rooms with dimensions 3.3m x 3.8m and 3.0m x 3.8m. Diagnostic Centre E and F have room dimensions 3.5m x 3.4m and 4.0m x 3.2m respectively. Both centres were purpose- built and a 2mm Pb were bonded with plywood on the wall of the rooms. Diagnostic Centre A has a room dimension of 5.0m x 4.0m with a minimum and maximum distance 100cm and 280cm from the x-ray tube to the nearest wall or protective barrier. A 2.23mm lead sheet bonded to plywood was

used as the shielding material. Diagnostic Centre B has a room dimension of 8.0m x 5.0m with a minimum distance of 3.8m to the console area. This centre is purpose-built with a minimum wall thickness of 0.3m around the X-ray room. Diagnostic centre C has a room dimension of 4.0m x 3.2m. the walls of the X-ray room were made with ordinary hollow blocks thereby offering no protection for the workers and patients. Diagnostic Centre D has two X-ray rooms with dimensions 3.3m x 3.8m and 3.0m x 3.8m. Diagnostic Centre E and F have room dimensions 3.5m x 3.4m and 4.0m x 3.2m respectively. Both centers were purpose- built and a 2mm Pb were bonded with plywood on the wall of the rooms (Figure 2).

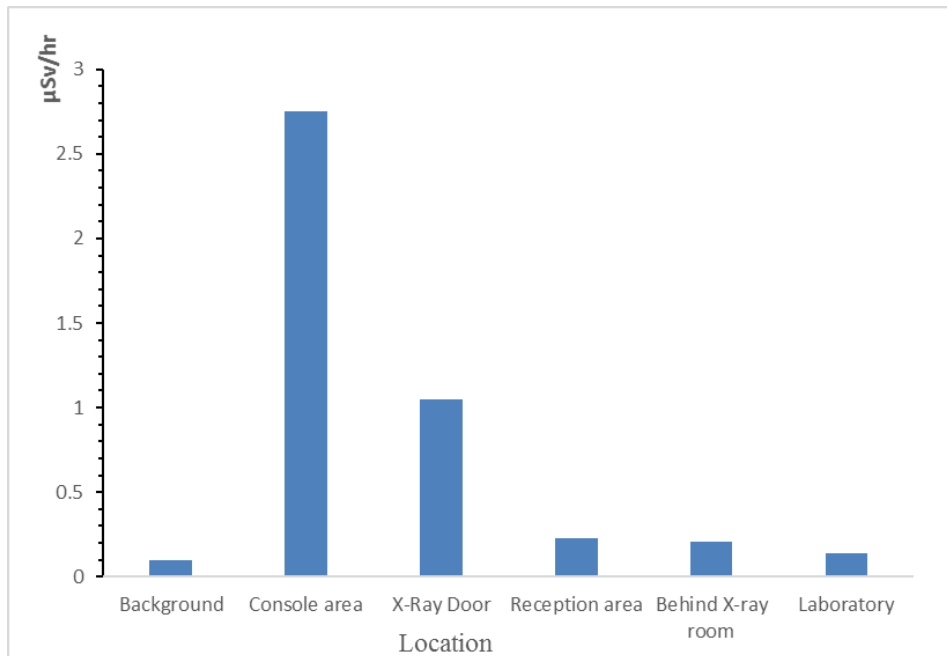
**Figure 1:** Radiological facility A Radiation Dose rate at different locations

The building was purposely built which was clearly seen in the radiation dose rate data as presented in Figure 1. The receptionist’s area, behind X-ray room door and the laboratory room were found to have satisfactory levels <0.5µSv/h of radiation dose rate as recommended by NCRP (NCRP, 2015). The radiation dose rates measured in the consol area and X-ray room door read 2.75µSv/h and 1.05µSv/h respectively. As clearly shown in Figure 1 the technician has an estimated annual dose ( $D_{eff}$ ) of 0.165 mSv which is the highest in the facility but seen to be < 0.96mSv as recommended by National Council on Radiation Protection and Measurements (NCRP) Report 147 and International Commission on Radiological Protection (ICRP). The radiation dose rate of diagnostic facility A were found satisfactory and reads (0.14 – 2.75 µSv/hr).

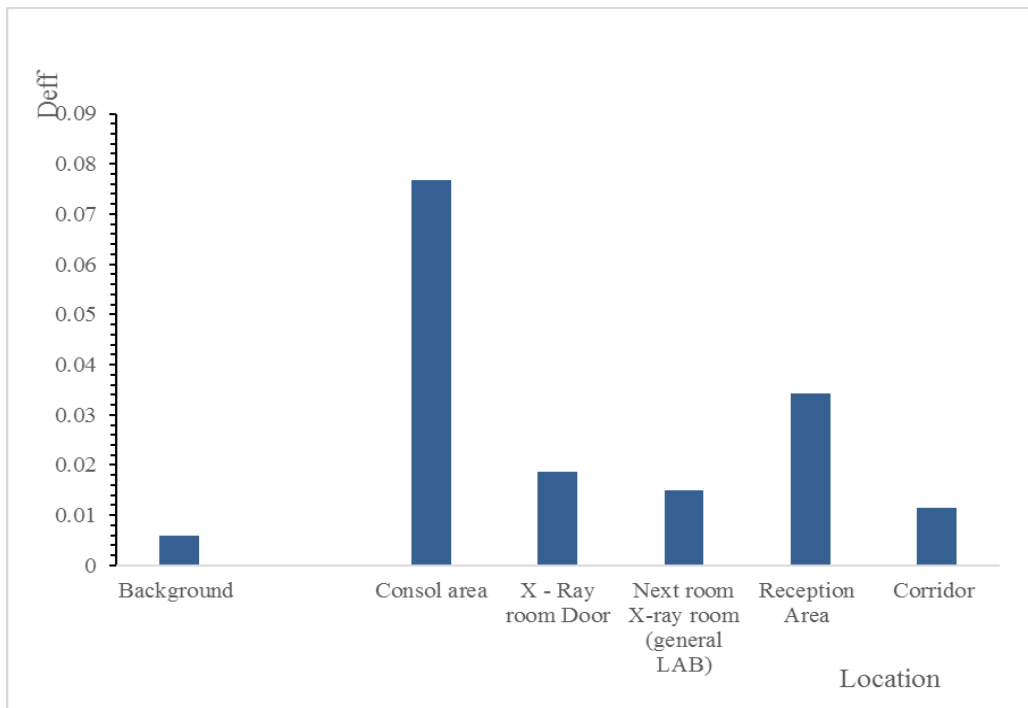
**Figure 2:** Annual effective dose at different locations in the study area B

The X-ray machine in diagnostic Centre B was manufactured about fifteen (15) years and purchased seven (7) years ago. The X-ray Machine model is 300Ma Medical Diagnostic X-Ray Machine and has a maximum kVp of 120 and 300 mAs. 100kVp and 50mAs was used for the study. The distance of the X-ray tube to the dummy object is 1.5 m. From Figure 2, the consol area which is a small caved out space inside the X-ray room, with a

radiation dose rate of 1.28µSv/h has an estimated annual dose of 0.0768 mSv/week for the technician is < 0.96mSv/week as recommended by NCPN. However, the X-ray room door, general lab, reception area and corridor has dose rate (< 0.5µSv/hr) which is the satisfactory level. The radiation dose rate in facility B is (0.57 – 1.28µSv/hr). Facility B is purposely built facility and has a total of 18 staff that spends 10 hours daily.

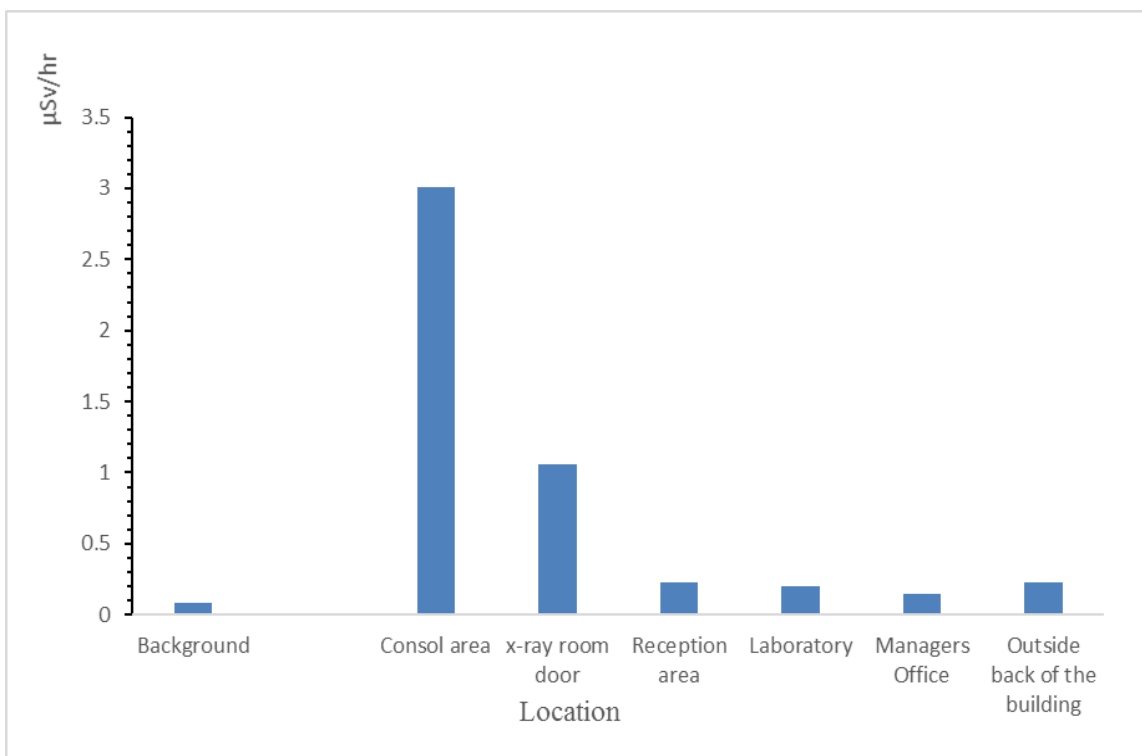
**Figure 3:** Dose rate at different locations in the study area C

The machine in Diagnostic Centre C is 300Ma Medical Diagnostic X-Ray Machine manufactured in October, 2012. 50kVp and 0.5mAs was used for the study while the machine has a maximum of 120kVp and 300 mAs. This diagnostic Facility is not a purposed built facility for diagnostic activities. The background radiation dose is within acceptable limit. The radiation dose rate is 0.08 $\mu$ Sv/hr - 3.8mSv/hr (Figure 3). The technician takes

procedures with his lead apron behind a small wood which he uses as console area. Diagnostic Centre C does not have any personal dosimetry service provider as recommended by the ICRP and NNRA. The estimated annual doses were calculated based on the dose rate at various locations in the Diagnostic Centre. The technician had the highest value in this center with an annual estimated dose of 0.1806mSv.

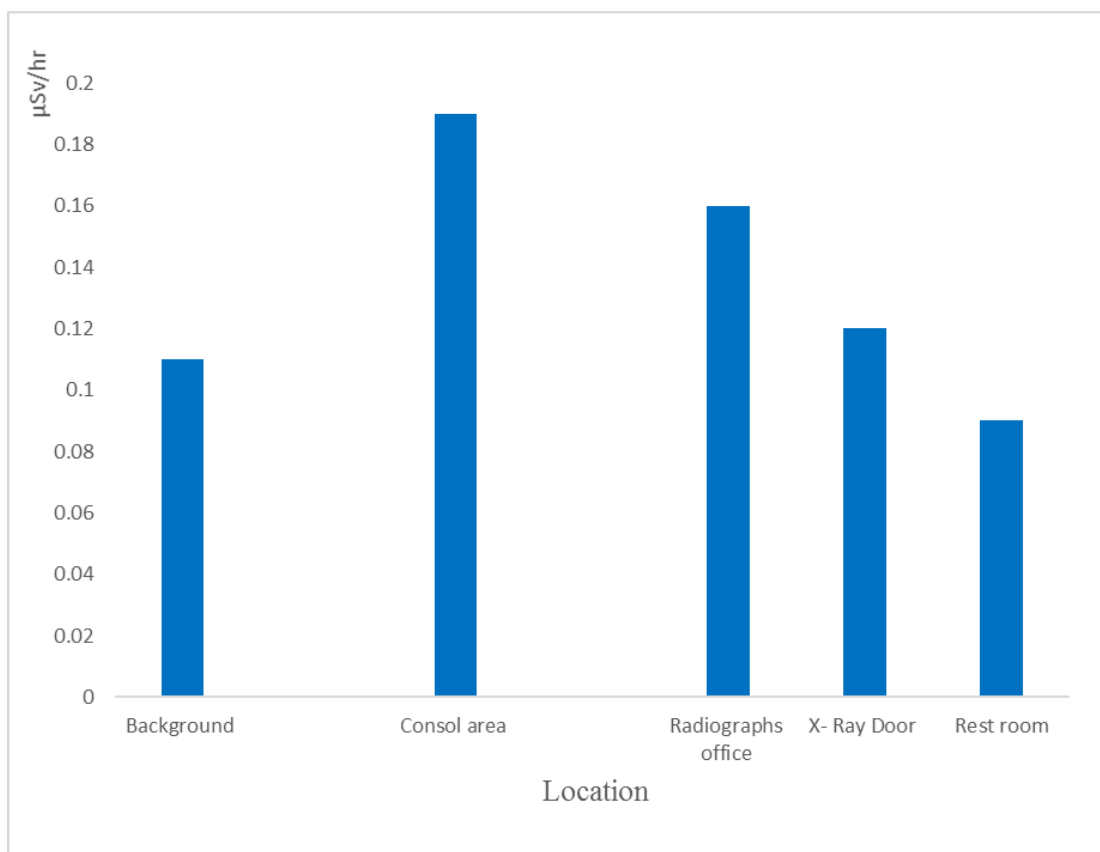
**Figure 4:** Dose rate at different locations in the study area D

Facility Diagnostic Centre D is one of the puposed built facility the study was carried out in, with a total of 23 staff. From Figure 4 as shown the radiation dose rate is (0.09 $\mu$ Sv/hr - 0.19  $\mu$ Sv/hr) which is within the satisfactory level (<0.5 $\mu$ Sv/hr) this means that the X-ray room is well

shielded thereby the persons and public are in save based on my study. The effective dose is 0.0066 which is < 0.96 mSv/ week as recommended by NCRP. The machine model is Allengers High Voltage Double Tank manufactured October 2015.

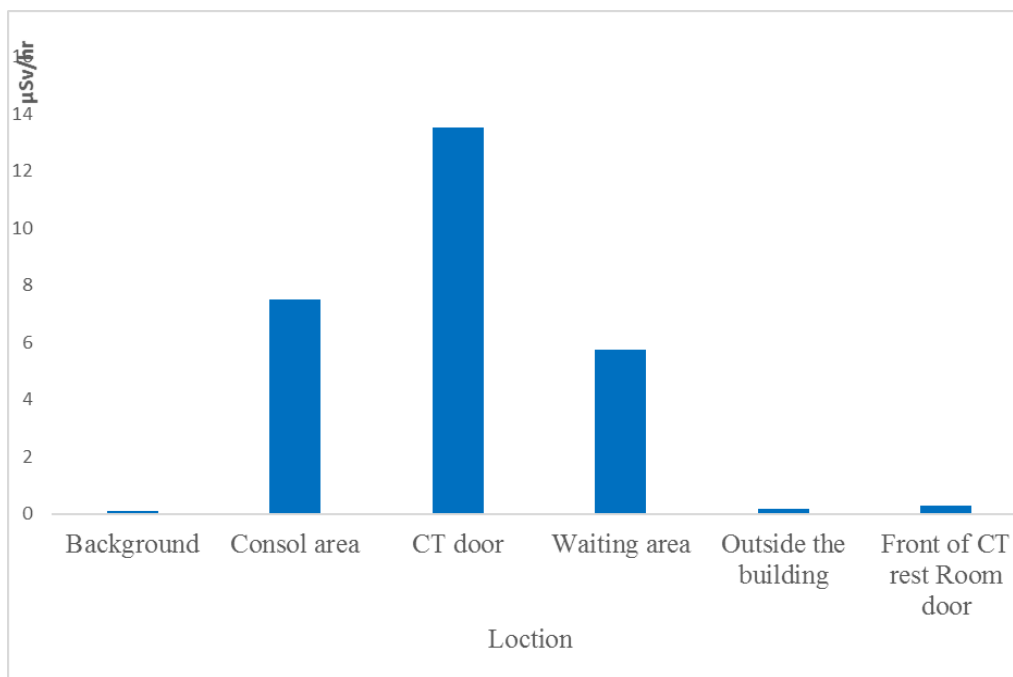
Figure 5: Dose rate at different locations in the study area E

Radiological Diagnostic Centre E as presented in Table 5, the wall of the CT room is shielded with lead sheets and the survey meter measurements showed very low dose rates. This is in compliance with regulatory standards. The estimated annual dose to workers as presented in Table 5 showed that the dose rates are within the recommended values. The highest estimated annual effective dose is 0.81mSv/week which is within the recommended dose limits for occupational radiation workers of 50mSv/a by International Commission on Radiological Protection (ICRP). From Figure 5, Diagnostic facility E, the background radiation dose is normal, the radiation dose rate in the facility is (0.27  $\mu$ Sv/hr - 7.51

$\mu$ Sv/hr). Machine use for the study in the particular facility is a computed tomography machine and no dummy object was used as the exposures were all done with real human but with different kVp and mAs as different procedures (Lumbosacral, Chest, Neck etc) were taking place. From figure 4.9 the CT door has the highest dose rate 13.5  $\mu$ Sv/h and the door is very close to the waiting area. This is hazardous to the public and personal who have activity to do within there. The public limit is 0.019mSv/week. The console has a radiation dose rate of 7.51  $\mu$ Sv/h and estimated annual dose rate of 0.4506 mSv/h.

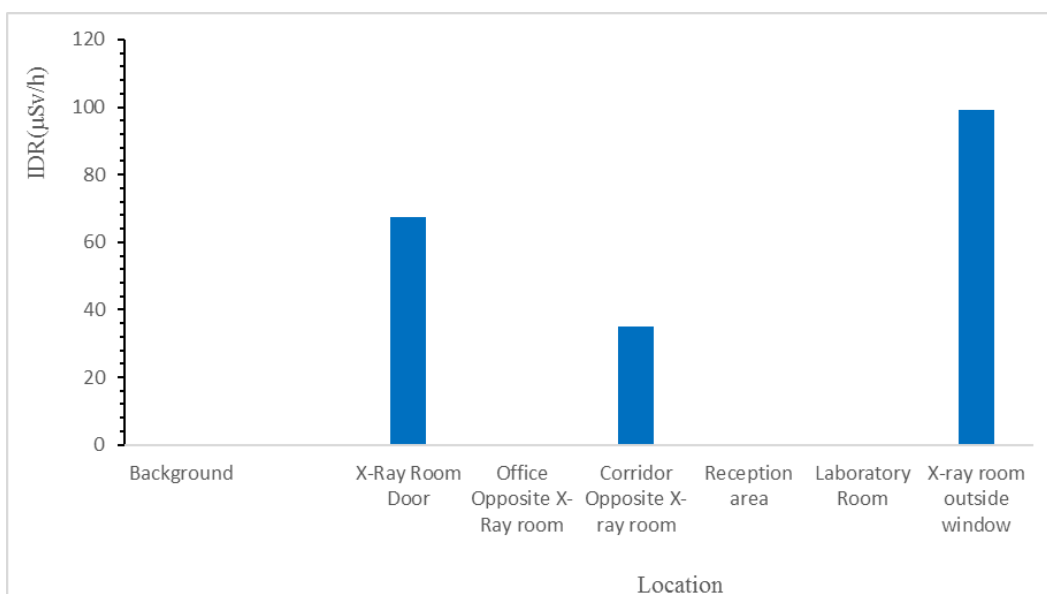
Figure 6: Radiological facility F Radiation Dose rate at different locations.

As well shown in Figure 6, the receptionist's area, general waiting area and the laboratory room were found to have satisfactory levels <0.5 $\mu$ Sv/h of

radiation. However, the radiation dose rates measured in the X-ray room door is 67.57 $\mu$ Sv/h with  $D_{eff}$  of 4.05mSv/h where the technician stands when taking exposures and corridor opposite the X-ray room door 35 $\mu$ Sv/h are very high there by personnel and public within the facility who will be present within this point while exposure is being taken will be at a very high risk. X-ray room outside window which is also very close to where people are living have a very high dose rates, this means that everybody who stays in that particular building will always receive a very high effective dose rate of 5.94mSv/h each time exposure is taken even without going to radiological facility. The radiation dose rate of diagnostic facility F were found very high at these three points and reads (29 - 99  $\mu$ Sv/h).

- iv. Specifically, replacement of the ordinary wooden door to the X-ray room with one suitable for radiation protection for center F.
- v. Use of radiation warning stickers on the door around the X-ray room (Centre F, G and H). Suspension of the use of the X-ray equipment till some reasonable safety measures are put in place (Centre F, G and H) this include proper lead-lining of the X-ray room and use of other shielding barriers.

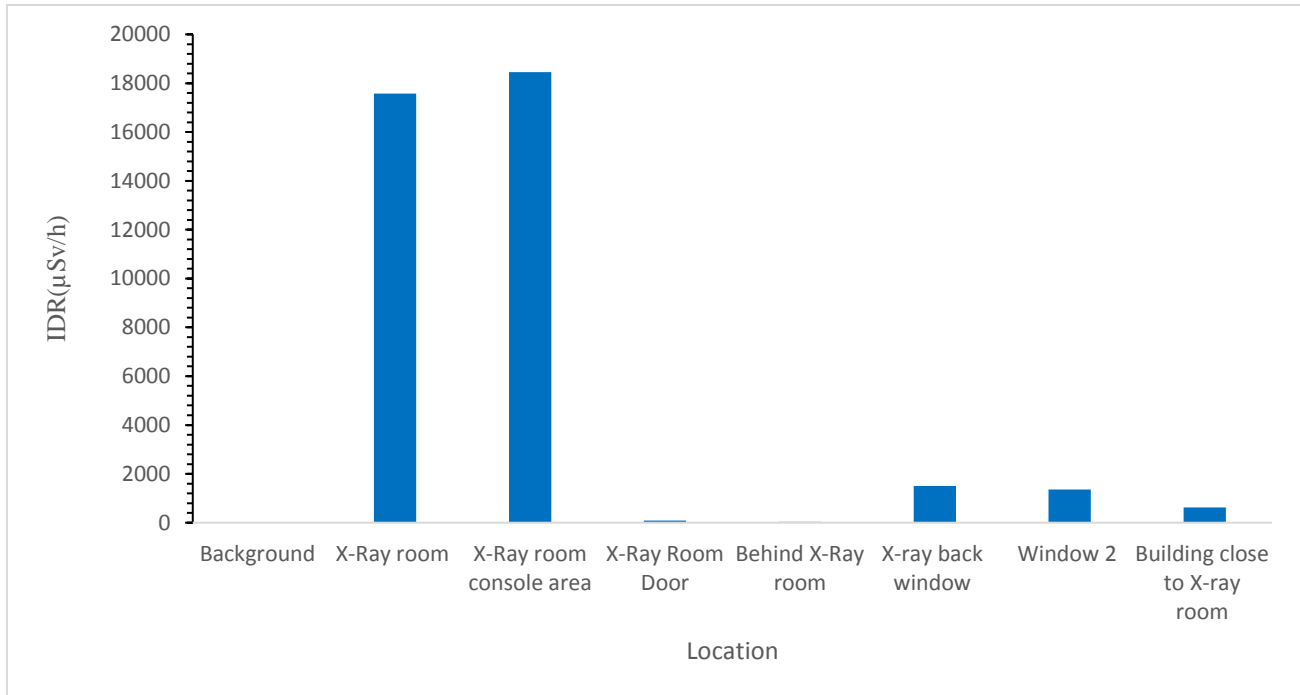
Figure 7: Radiological facility G Radiation Dose rate at different locations

Diagnostic Centre G has the result is presented in Table 8. The facility has nine workers; it is very clear that there is a danger. The technician stays in the same room were the X-ray machine is while taking exposure without any standing barrier (consol). The background dose rate is normal but while espousing, every other location measured was very high. Where the technician stands with only his lead apron reads 18.45mSv/h (18,450µSv/h), X-ray room door (86µSv/hr) and the outside window (1.36mSv/hr) which very hazardous to X-ray technicians and the public

living very close to the X-ray window as was sighted. The radiation dose rates in this facility G is (46µSv/hr – 18.45mSv/hr) with  $D_{eff}$  (2.46mSv/h - 1054.8mSv/h) which more than the NCRP recommended dose of 0.96mSv/h The X-ray machine model is AMX 4Plus and was manufactured July2003 (Figure 7). Have a maximum kVp of 125 and maximum mAs 200. 120 KVP and 64mAs was used during this assessment. The distance of the X-ray tube to the dummy object is 1.5m.

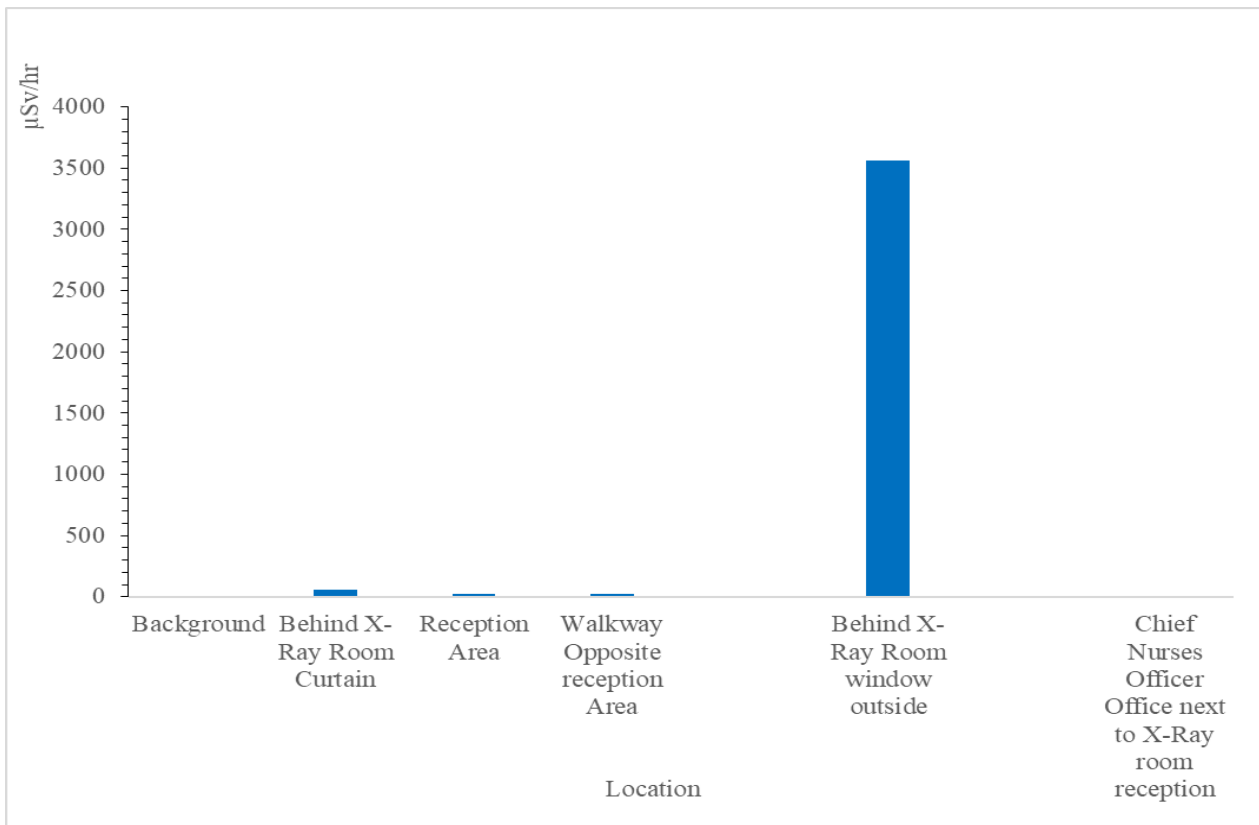
Figure 8: Radiological facility H Radiation Dose rate at different locations

Diagnostic Centre H as shown in Figure 8, the background radiation dose is normal. The radiation dose rate in this facility is 0.25µSv/hr – 3,560µSv/h which is hazardous to the personnel and the public. The technician takes exposure with only her lead apron which is enough to protect her as she stays in the same room while exposing no consol area

was noticed. The does rate is extremely high as seen in the estimated annual dose (0.015mSv/h – 213.6mSv/h). The X-ray machine model is F100 surgicare, installed 2020 and Manufactured August 2007. Maximum/Minimum rang of kVp and mAs (40 – 80 kVp and 15 – 60 mAs). 80 kVp and 60 mAs was used for the assessment.

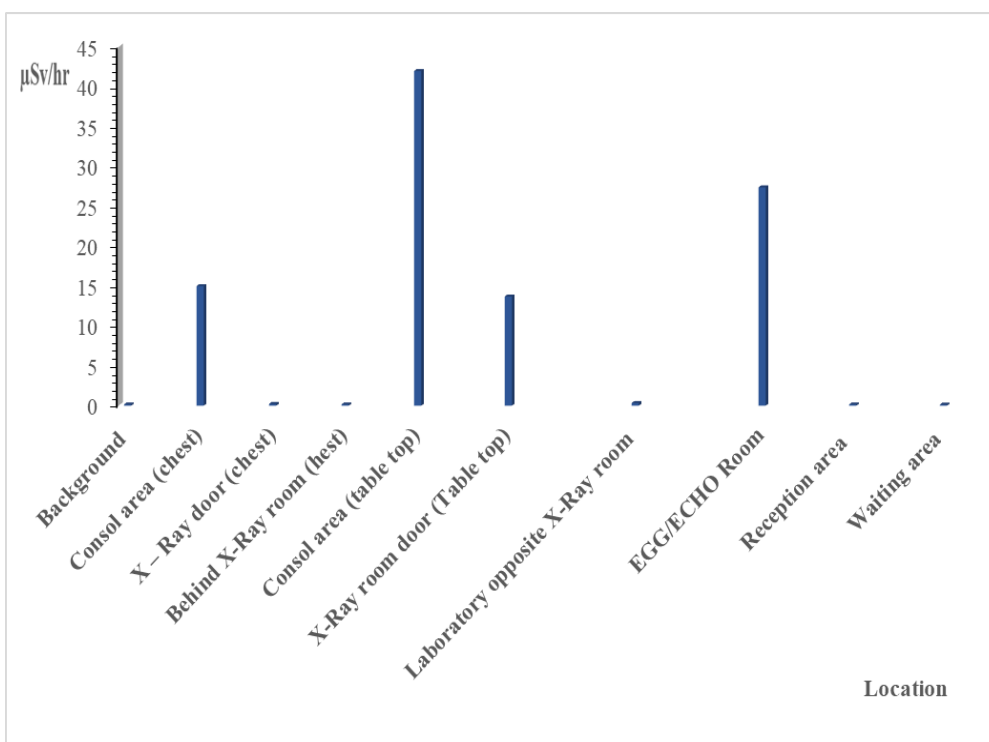
Figure 10: Radiological Facility J Radiation Dose Rate

From Table 10 facility J, the receptionist’s area, general waiting area and the laboratory room opposite the X-ray room were found to have a minimal level (<0.5μSv/hr) of radiation. However, the EEG/ECHO room and the console area were found to have radiation dose rates (27 - 42μSv/hr) higher than the required normal rage. The model of the X-ray

machine is Siemens Mobile ETT plus Hp manufactured 2003 and installed 2017. Distance of 1.5m was used during the assessment. The machine has kVp range of 40 - 133 and mAs rage of 0.50 - 32kVp. However, kVp of 81 and mAs of 28 was used (Figure 10).
